REPORT ON FISH AGGREGATING DEVICES WORKSHOP

Walter M. Matsumoto, Rapporteur  
Honolulu Laboratory, Southwest Fisheries Center  
National Marine Fisheries Service, NOAA  
Honolulu, Hawaii 96812

December 1980

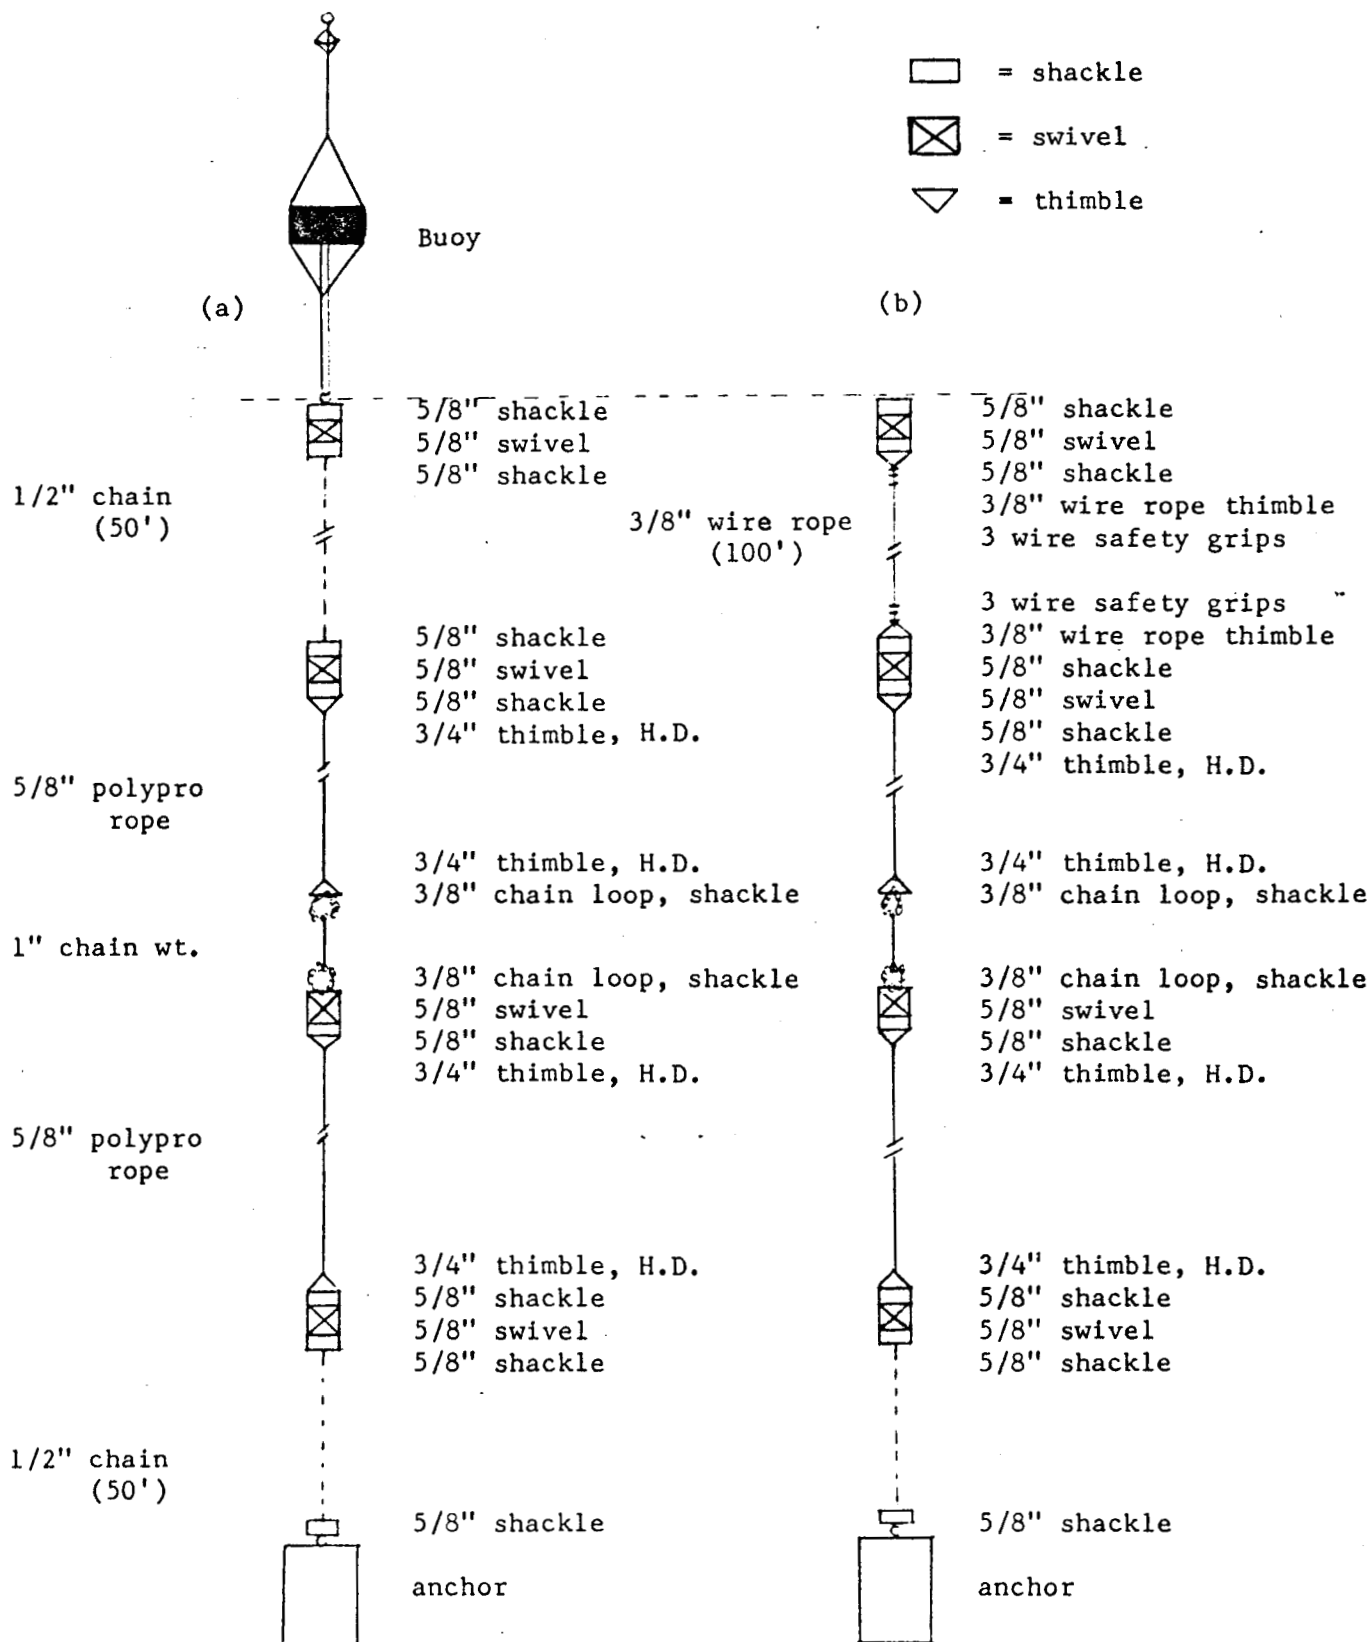
Figure 1. NMFS mooring line configuration.

The original set of four devices off Oahu and Lanai included a short section of 3/8-in. wire rope, fitted with floats, which was attached to the mooring line between the rope and anchor chain. Because copper nico-press sleeves were used to fasten the thimbles at both ends of the wire rope, this part of the line failed after about 2 months due to electrolysis. This section was omitted from later buoys because the buoyance of the polypropylene rope was sufficient to keep the line off the bottom.

During the remainder of the experiment, six more devices were lost at the four sites. Three from undetermined causes after 4, 17, and 20 months, two from causes other than mooring line design failure (one by rope chafing on bottom ledge, the other after having been dragged by currents to shallower waters where line chafing presumably occurred at the intermediate weight), and one due to loss of shackle pin. Only two of the six lost buoys were recovered.

Off Kona, four devices were lost at two sites. The initial two devices made of wooden rafts were lost as the rafts broke apart during a storm with winds in excess of 80 knots. The two replacement buoys, made of 55-gal drums, were moored by lines consisting of 100 ft of 3/8-in. wire rope at the top in place of the chain section, were also lost; one from undetermined causes, the other, as the cable grips became loose.

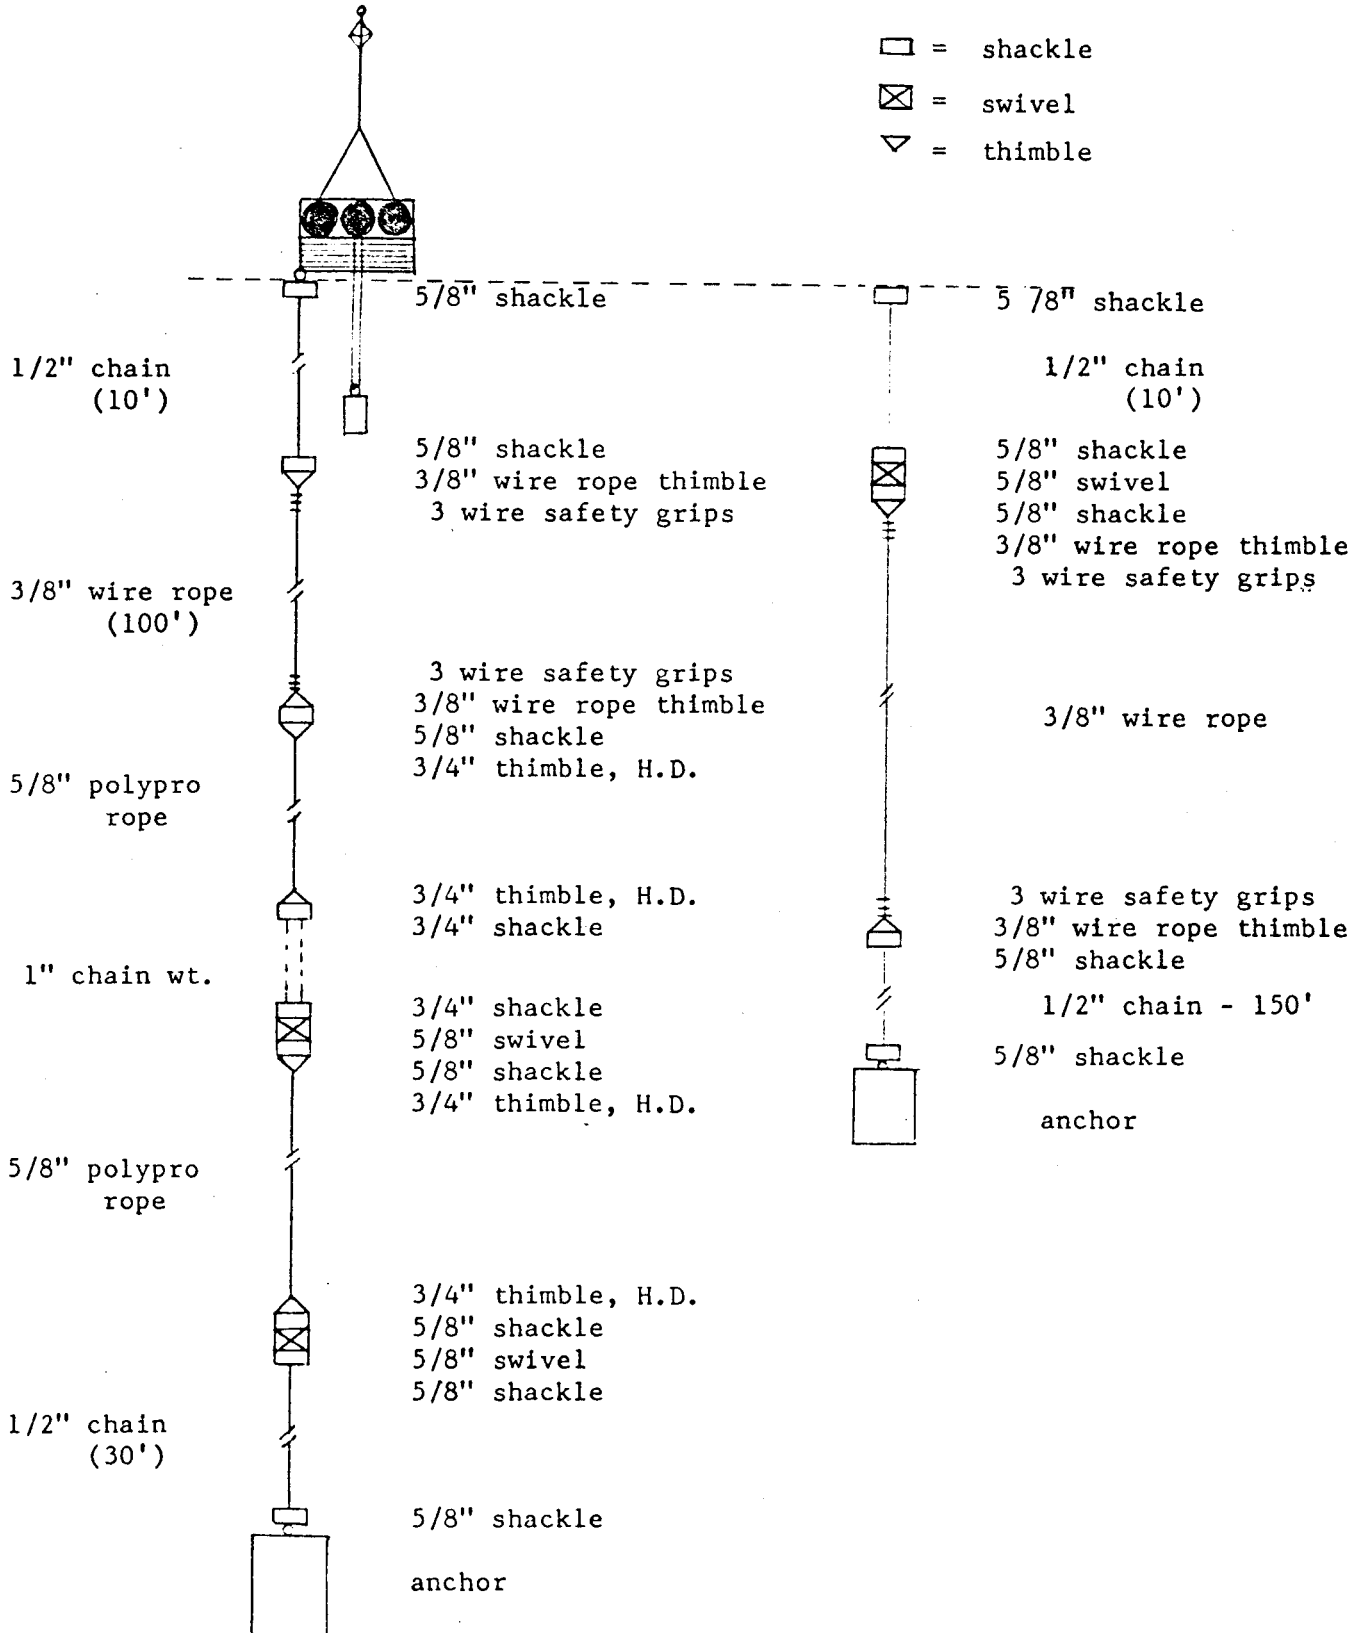
Figure 2. American Samoa mooring line configuration.

After learning about slippage in the safety wire grips in the Hawaiian experiment, the wire rope section was altered so that it was removed from some of the deep moorings and added on to others (doubled up). Thus, five buoys were set without the wire rope section, two were set with double wire rope section, and two were set with single wire rope section. The wire rope on the shallow mooring was also doubled up.

Of the 10 devices moored in October 1979, 6 were either lost or reported missing to date. Of the four remaining buoys, three had no wire rope section and one (shallow mooring) had double wire ropes. Of the buoys that broke free, one did so as a result of being overrun by a tugboat. The other confirmed breakage occurred at the rope section beneath the wire rope at the end of the splice. It was believed that the absence of a swivel at the junction of the wire rope and the rope section was the cause of line failure. The broken end of the rope showed signs of having been twisted.

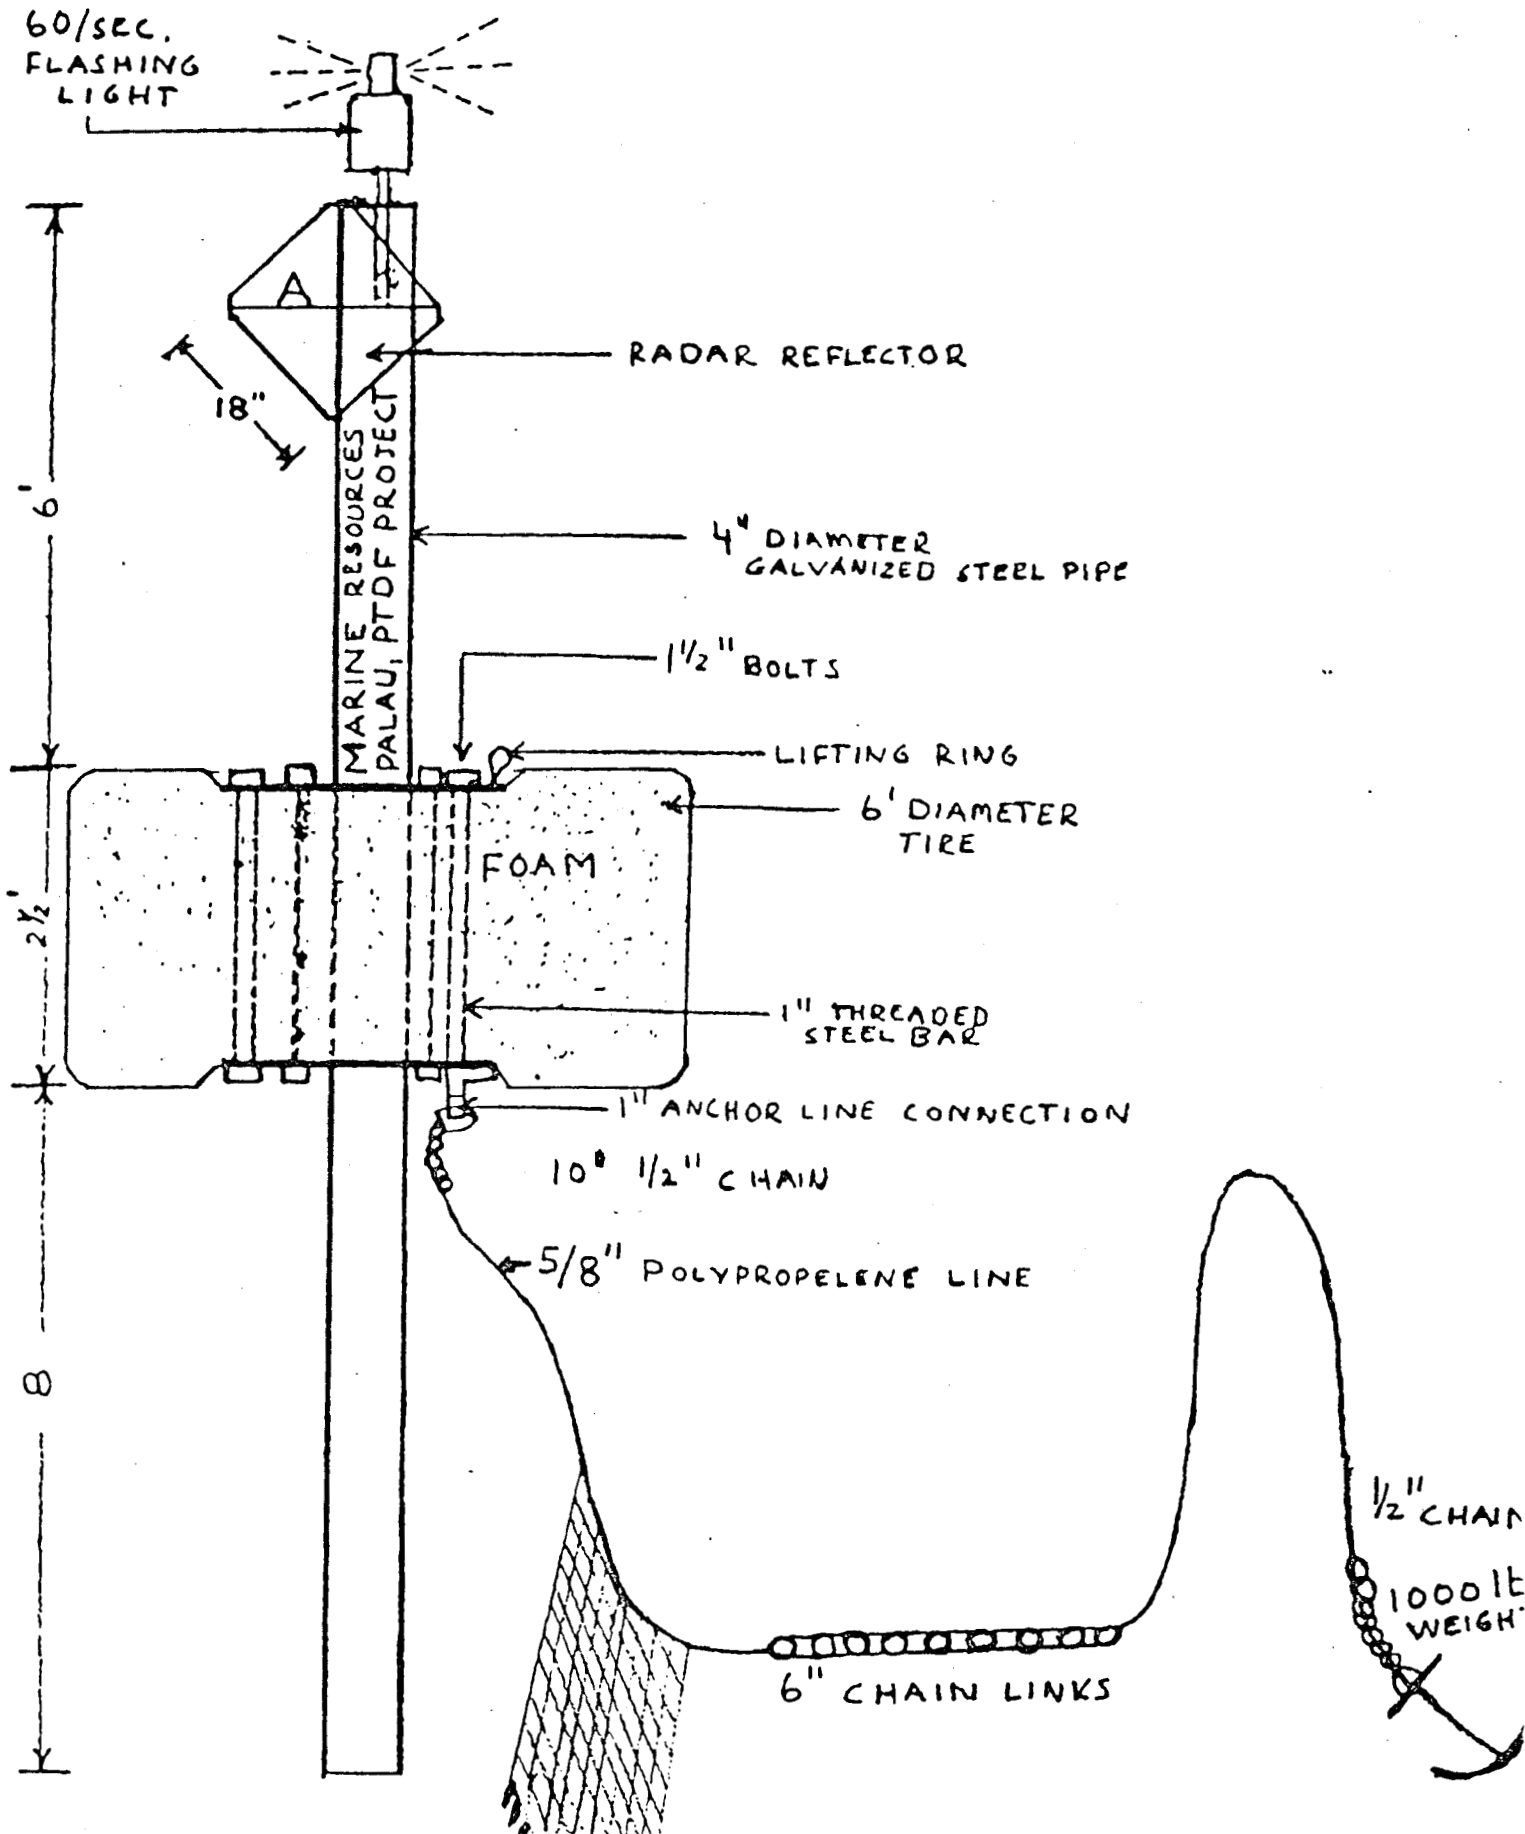
Figure 3. Palau FAD and mooring configuration.

Six FAD were moored in late July and early August, 1980 in depths of 600 to 2,022 fathoms, all with line scope of 1.6:1. To date, one FAD has broken loose. The cause of line failure has not been determined, but because the FAD were anchored in areas with numerous high steep ridges, there was a possibility that the line may have chafed against the ridges.

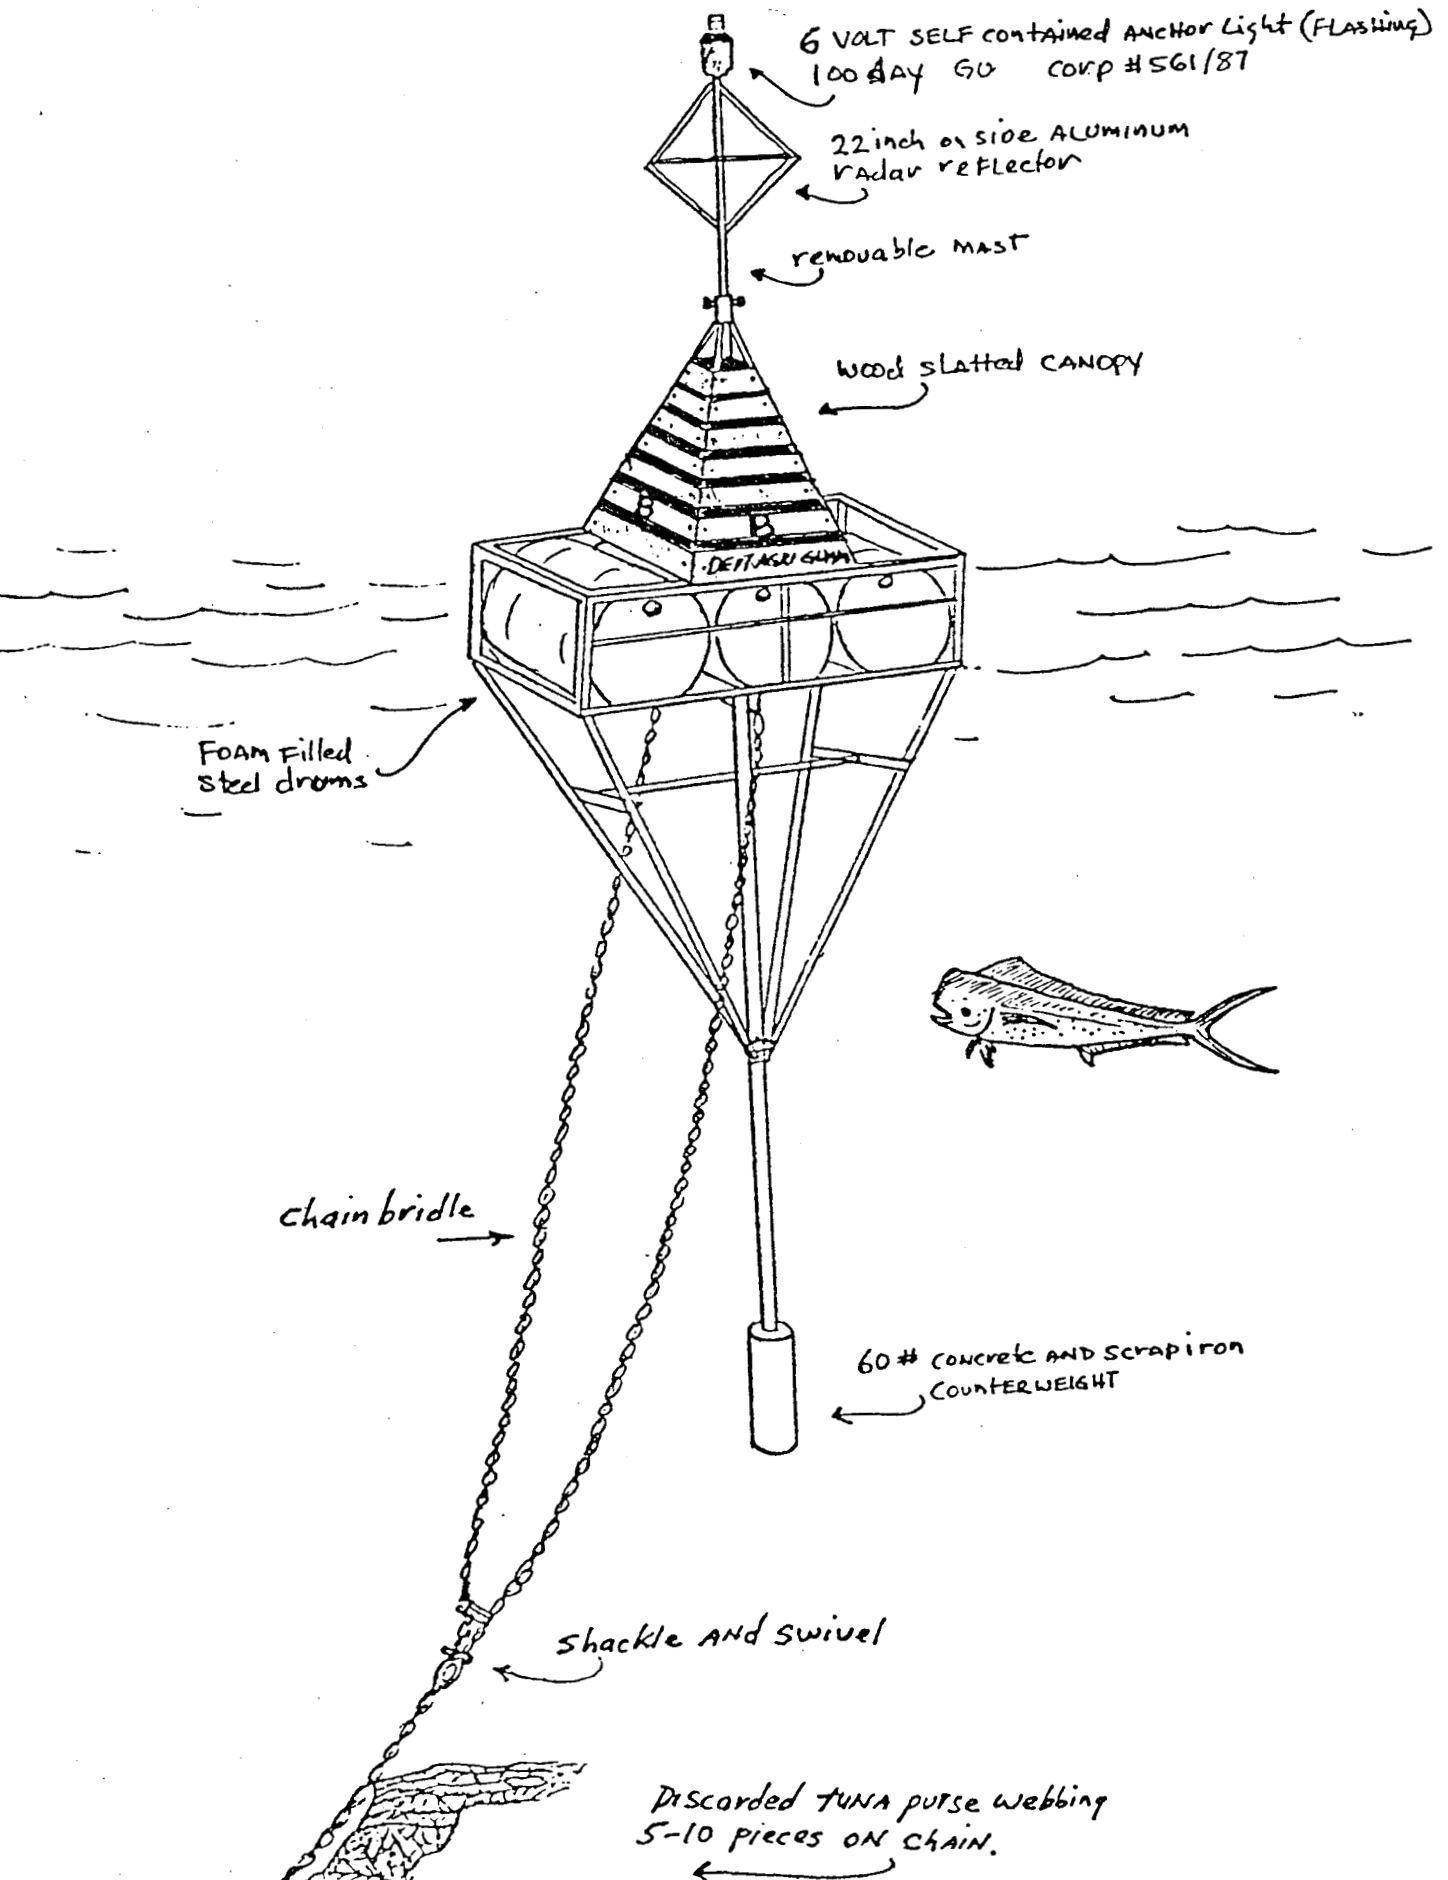
Figure 4. Guam FAD and mooring configuration.

Two devices were anchored in 300 and 510 fathoms in December 1979 and January 1980. Due to insufficient intermediate weight, the excess rope floated to the surface. The first device broke free within 1 week and was subsequently retrieved. It was believed that the floating line was severed by the propellor of a fishing boat. Additional weight was added to the mooring line of the second buoy as a corrective measure. This device also broke free in May. It was assumed that the break had occurred either at the intermediate weight or at a splice.

One of the two buoys deployed in April and June broke free recently. The break had occurred at the junction between the bridle and the upper chain section. The shackle was missing.

On the replacement FAD, the design was altered to a tire platform type and the rope size was increased to 3/4 in. Additional padeyes were placed on the buoy to permit small boats to tie up to it.

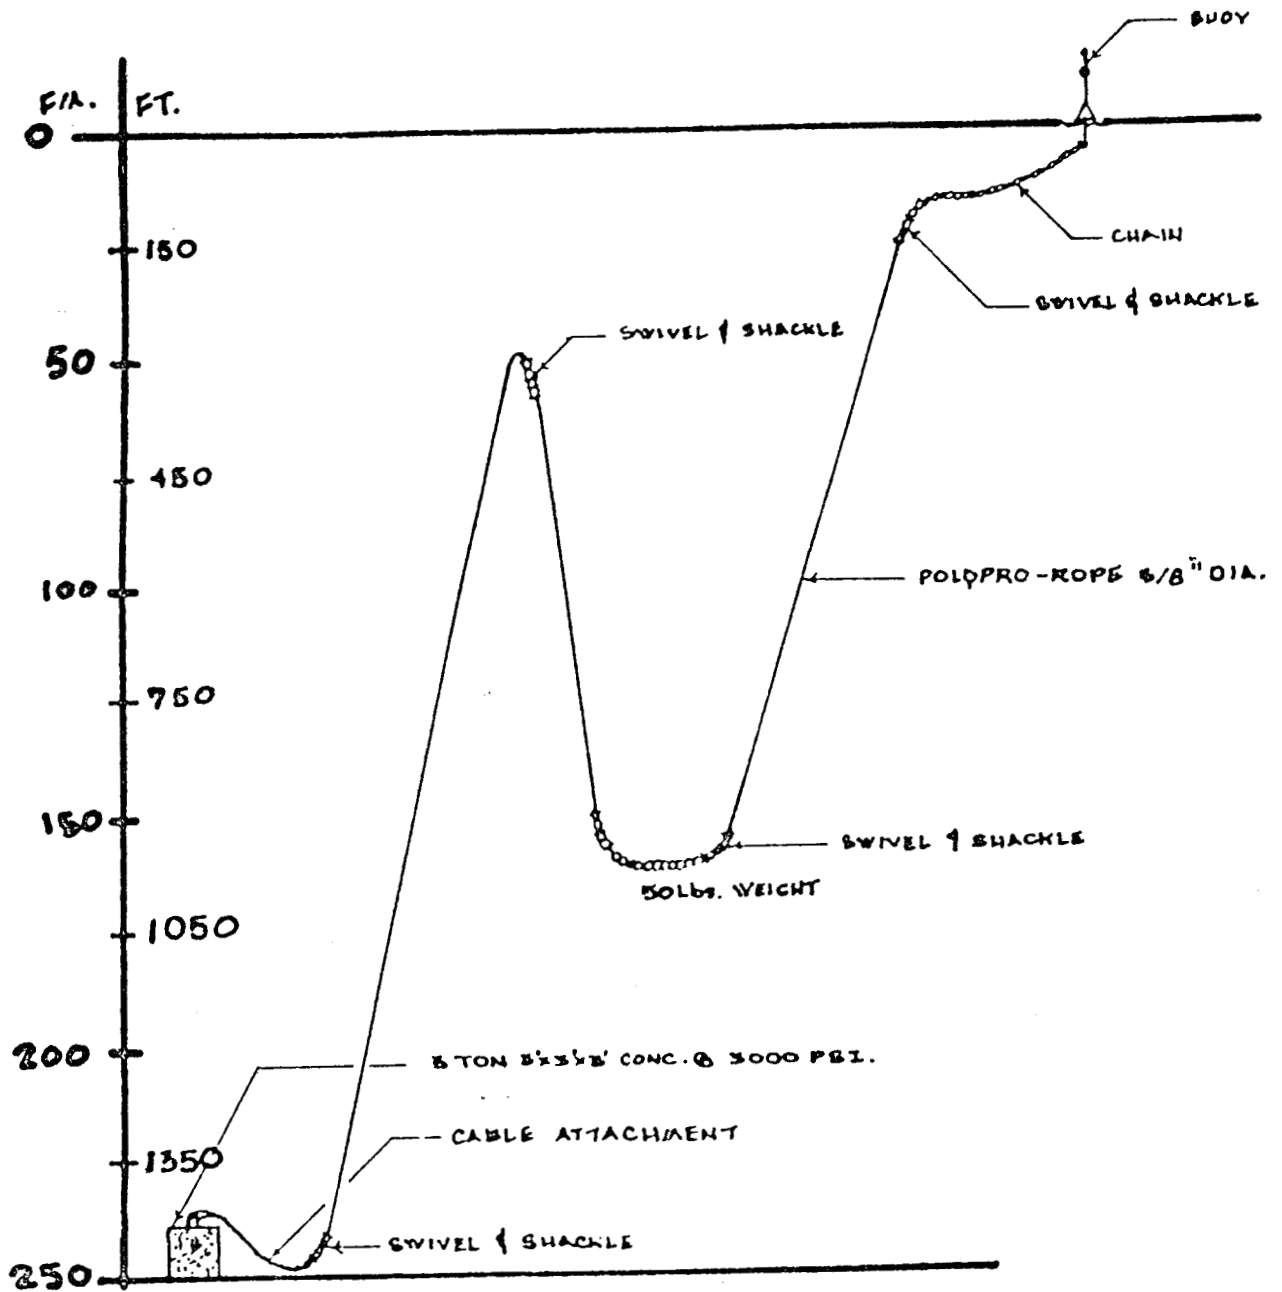
Figure 5. Marianas FAD mooring configuration.

Of five FAD anchored during February-March 1980, all have been lost. The FAD had been deployed without the aid of radar or depth recorder; consequently, one device was set too deep and disappeared from sight, two others were set too shallow and were probably lost as a result of the line chafing on the bottom at the intermediate weights. Two others showed signs of having been run over by passing vessels prior to their disappearance.

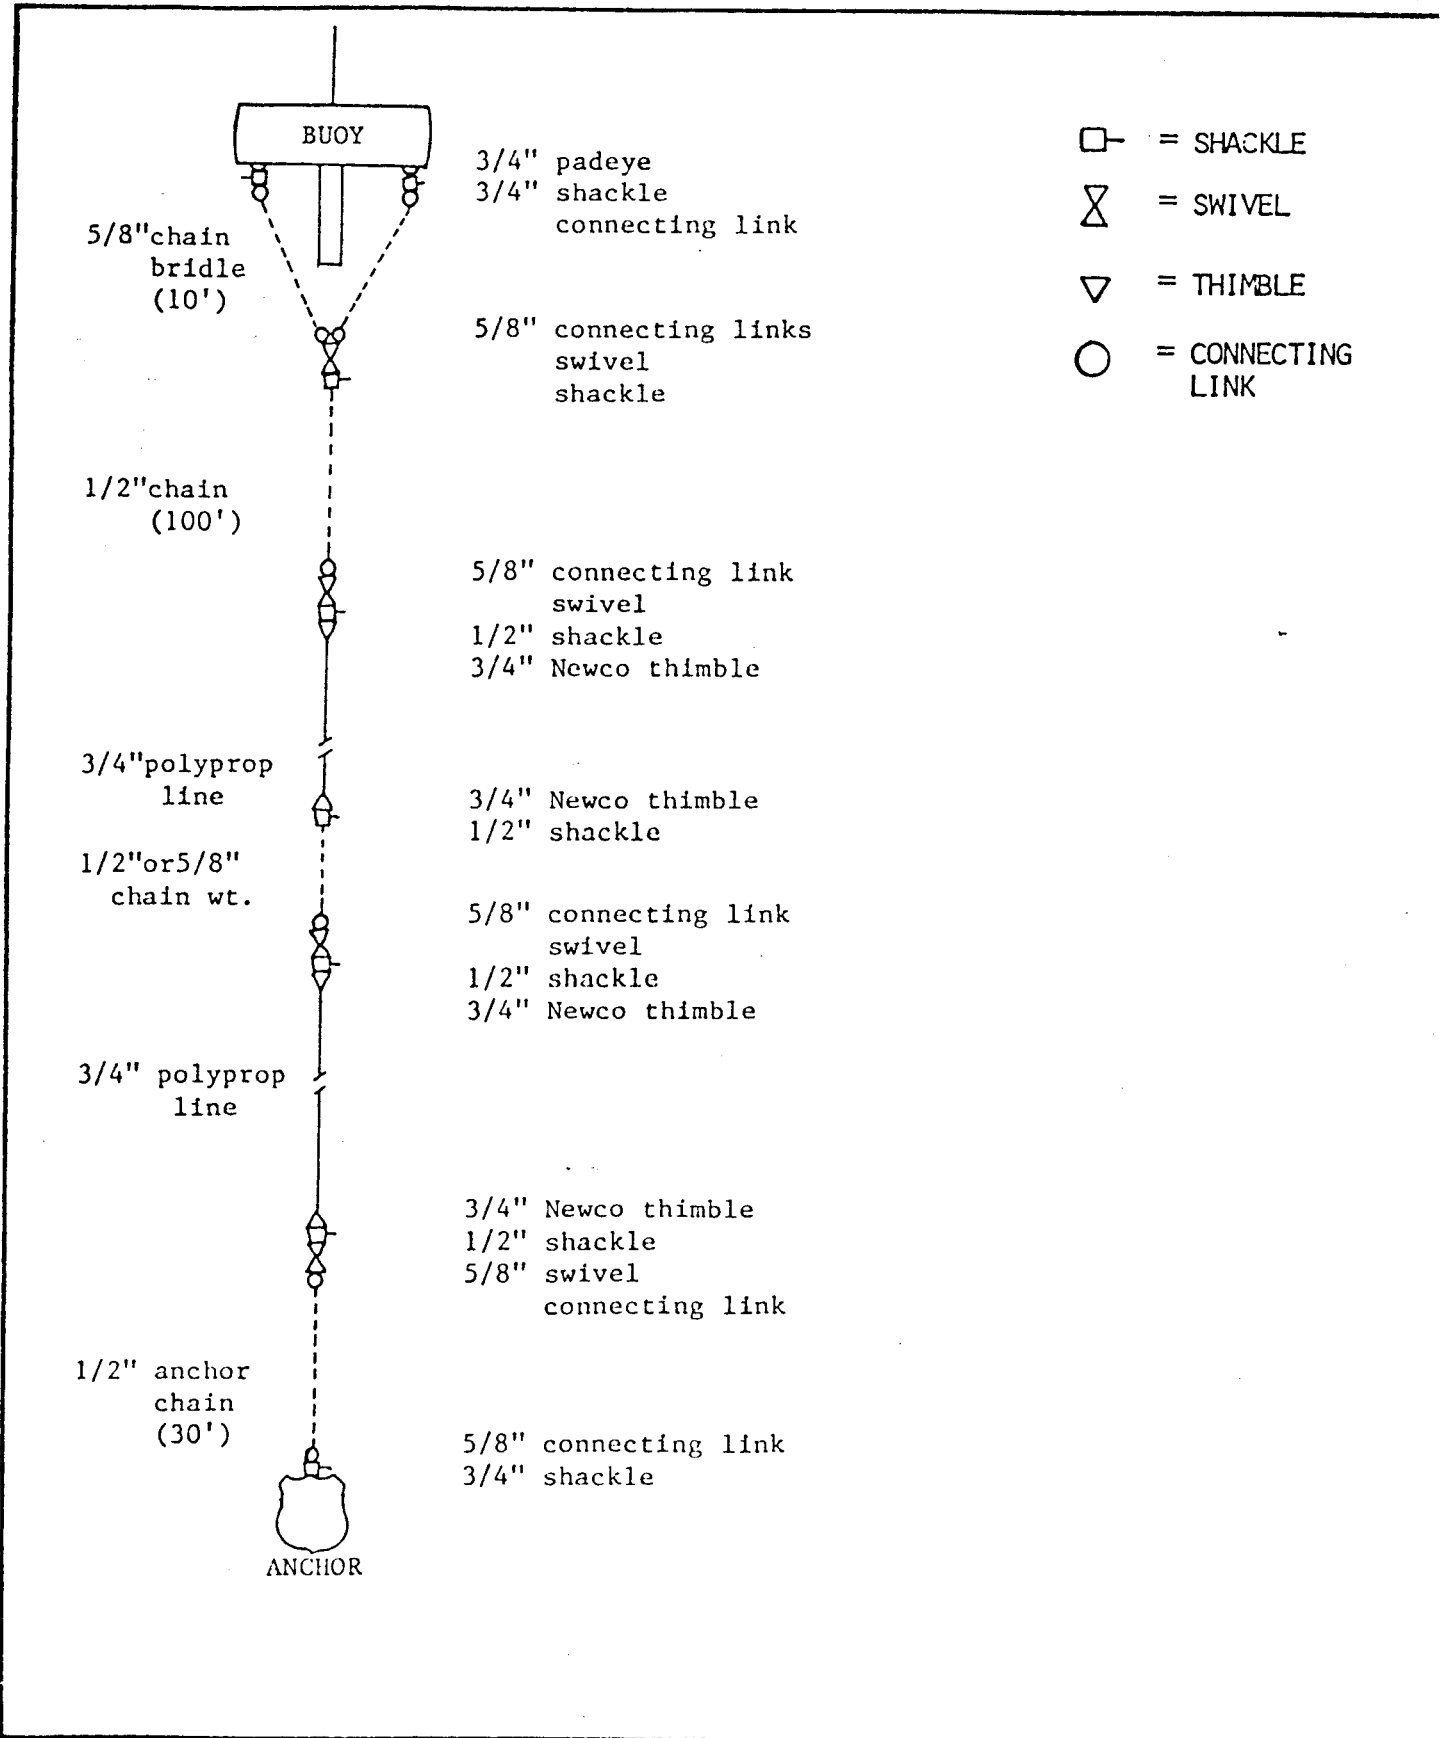
Figure 7. Hawaii Fish and Game mooring details.

Twenty-six FAD were moored around the main Hawaiian Islands between May and July between May and July 1980 in depths ranging from 250 to 1,200 fathoms. To date seven FAD have broken loose, three of which were recovered. One of the breaks was due to a tugboat topline. The second was probably due to splice failure, either at a thimble or between rope sections. The latter showed signs of electrolysis at the

bronze swivel after 5 months; however, bronze thimbles showed little, if any, corrosion. The causes of failure of the other five FAD were undetermined.
