REPORT ON FISH AGGREGATING DEVICES WORKSHOP

Walter M. Matsumoto, Rapporteur  
Honolulu Laboratory, Southwest Fisheries Center  
National Marine Fisheries Service, NOAA  
Honolulu, Hawaii 96812

December 1980

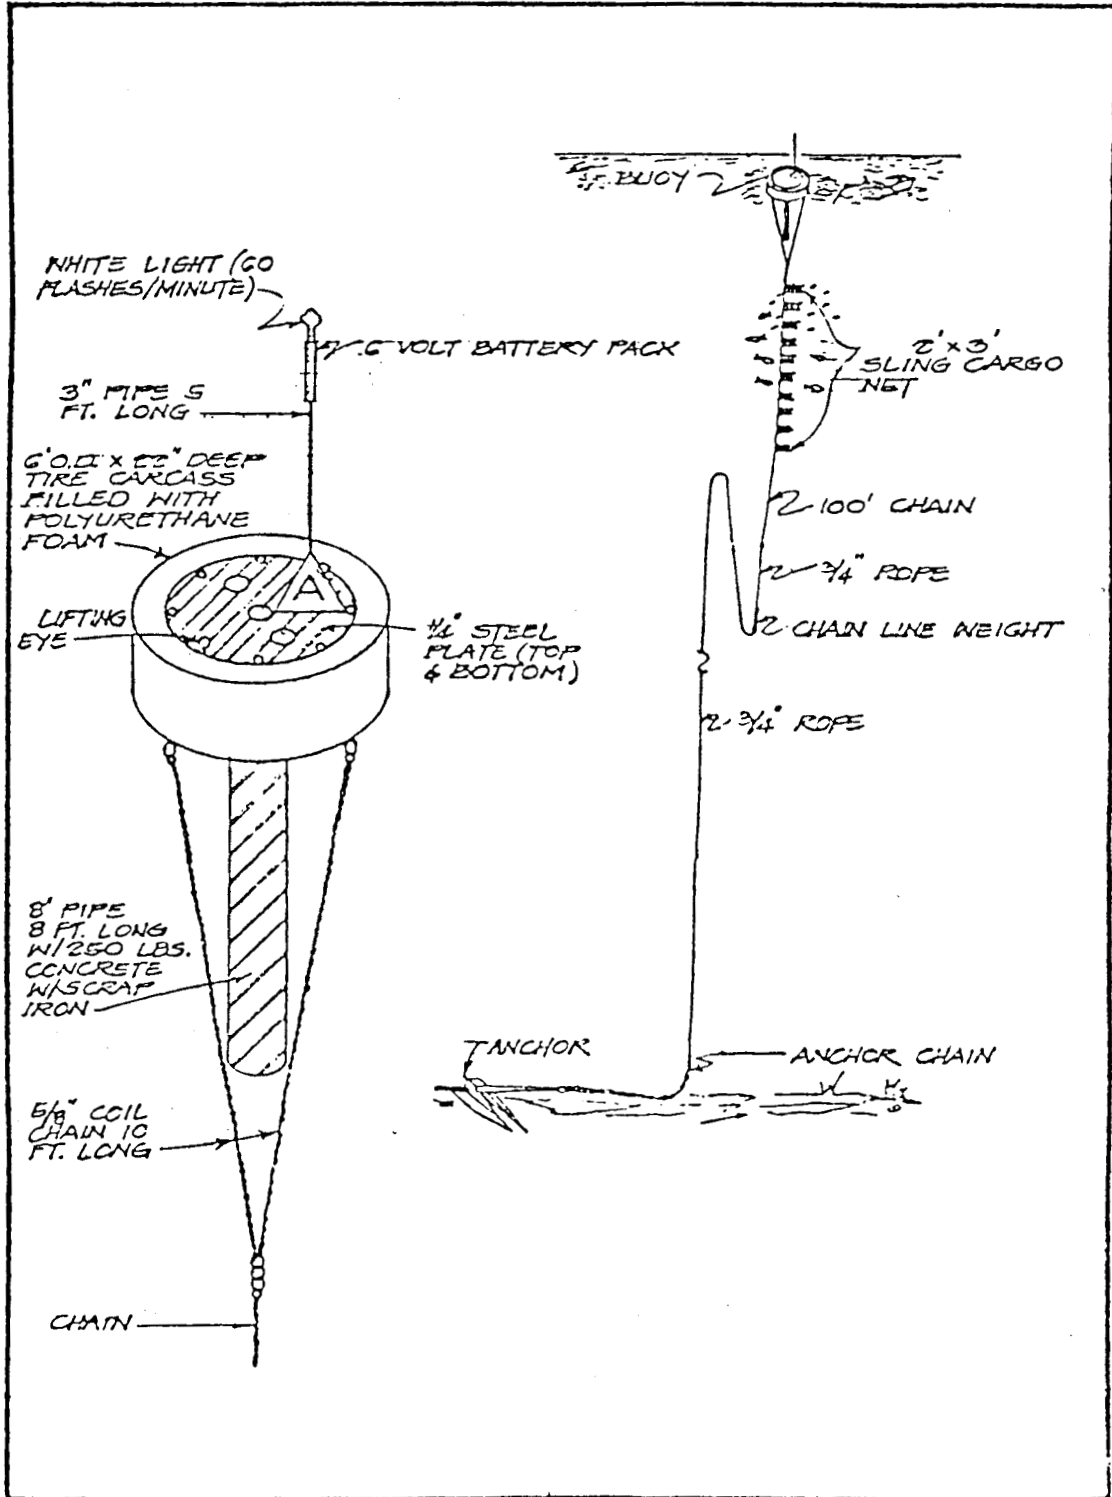
Figure 7. Hawaii Fish and Game mooring details.

The mooring line configuration is shown in Figure 7. The top of the bridle was shackled to two padeyes through a split chain connecting link. The lower end of the bridle was connected to a bronze swivel by split chain connecting links and the swivel was shackled to 100 ft of 1/2-in. chain. The lower end of the chain was attached to a swivel through a split chain link, and the swivel was shackled to the rope end fitted with a 3/4-in. Newco bronze thimble. Similar linkages were made below the intermediate chain weight and at the anchor chain. The top of the intermediate chain weight was linked without any swivel.

bronze swivel after 5 months; however, bronze thimbles showed little, if any, corrosion. The causes of failure of the other five FAD were undetermined.
